| <br>GREASE TRAP MAINTENANCE · COMPLIANCE<br><br>Tel: 1890 336633<br>Email: info@taylormade.ie | TITLE:<br>Installation Guide for Underground <b>BIOTRAP® 9520</b> | DRAWN BY: | SCALE: | |
| | CLIENT: Grantstown Proiry Care Centre | DATE: | MATERIAL: | APPROVED BY: |

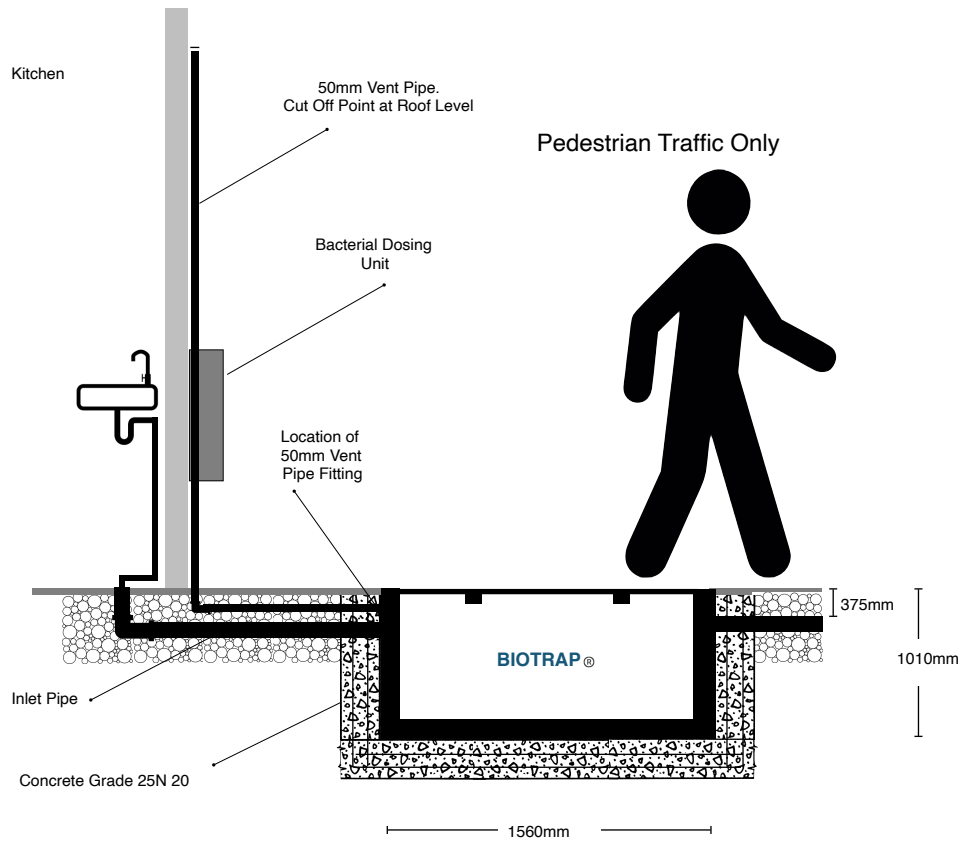
Side View

Notes: **DETAIL FOR BELOW GROUND INLET PIPE**
